**Documents concerning the age of
The Nebb, Flixton-by-Lowestoft**

Some hypotheses about the Nebb by Cherry Baden-Powell, 1994

Time line for the Nebb (by Piers Nicholson, October 2016)

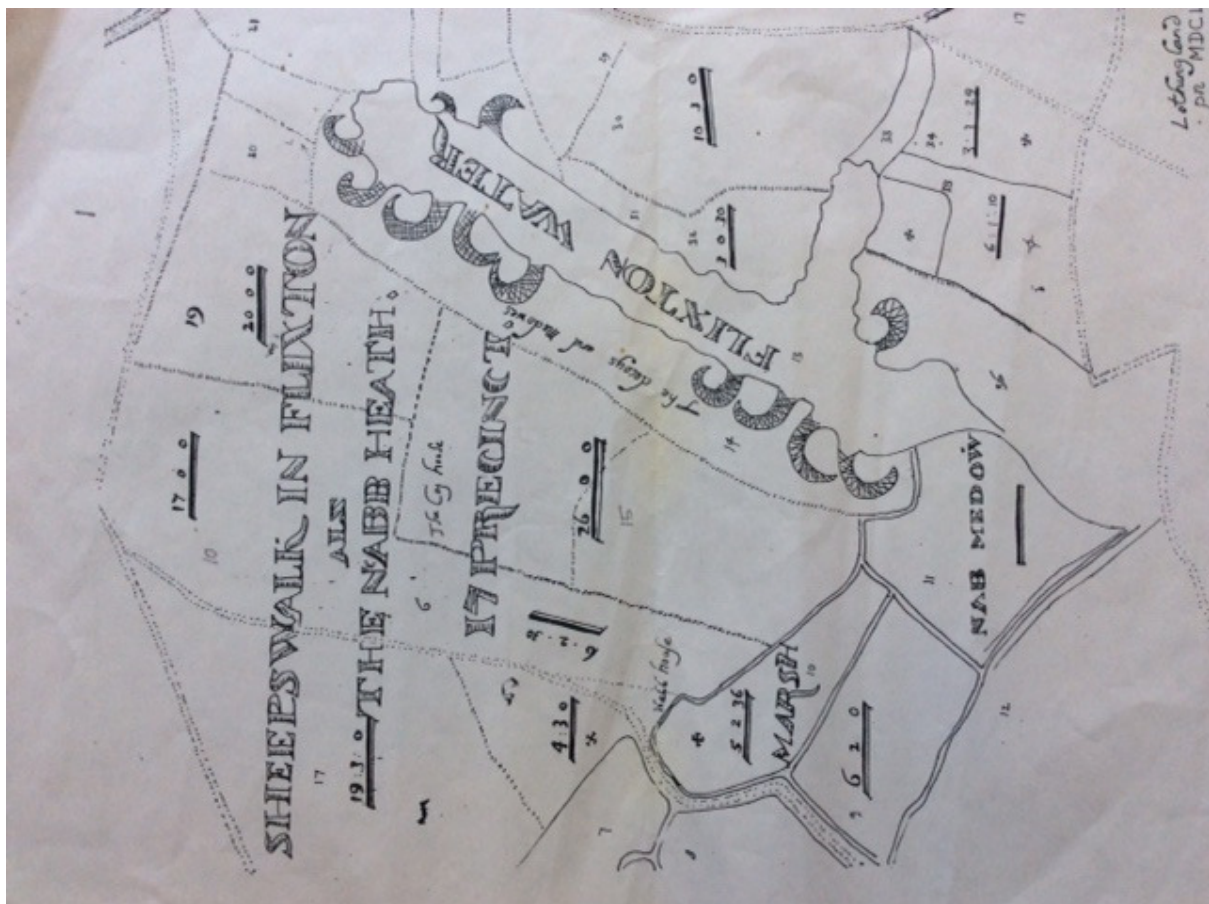
The map below was surveyed in 1614 by the new owner of the estate. When he died in 1652, the map was searched for, found, but was unusable because of damp and mildew. So they redrew from the survey notebooks; the redrawn map had the date 1652, which I had assumed till quite recently was the survey date. So the Nebb was certainly there in 1614.

The map has a number of interesting features:

- The road and track pattern is identical to what exists today.
- no houses are shown at the head of the lane (farhouse/ Warren Anne etc)
- the Coy house has now completely disappeared
- Nabb house indicates that it was reasonably substantial
- Flixton Water is the same shape as now but has 12 decoy arms (now gone)
- All the land in the 17th precinct has its area and the details of its owner – except the Nabb House (unfortunately)

This map provides the only thing known for certain about the Nebb – that there was a building on this site in 1614
